## Three Aspects Of Integrity

Michael J. Mills

Change Over Time, Volume 10, Number 2, Fall 2021, pp. 142-158 (Article)

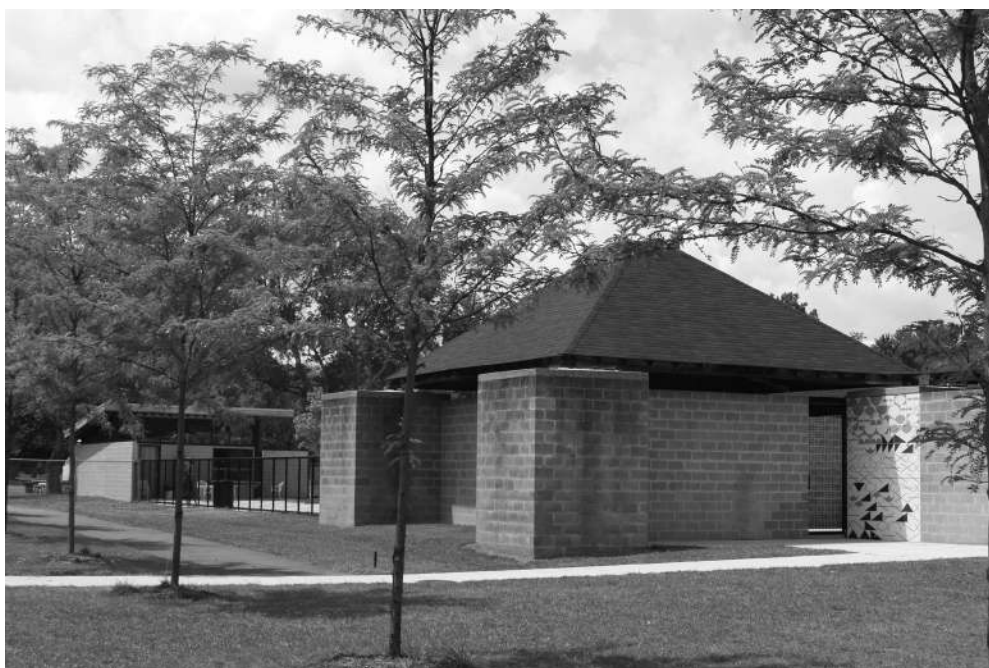
Figure 3. View after restoration showing entrance mural, the new Snack Bar, the plaza, and the Kahn-designed perimeter fence. Photo by author

The new Snack Bar was constructed of compatible materials such as concrete masonry, with walls built of standard gray block as opposed to the brownish gray and textured block specified by Kahn. It has a wood-framed roof like the Bath House but an inverted butterfly design separated from the block by glazing so that it "floats" over the masonry in the same way that Kahn's pyramidal roofs hover above the Bath House. The perimeter block wall intended to enclose the plaza between the Bath House and Snack Bar was not acceptable to the county or the township for environmental and security reasons, so a partial wall with steel fencing according to Kahn's design details was proposed and constructed.

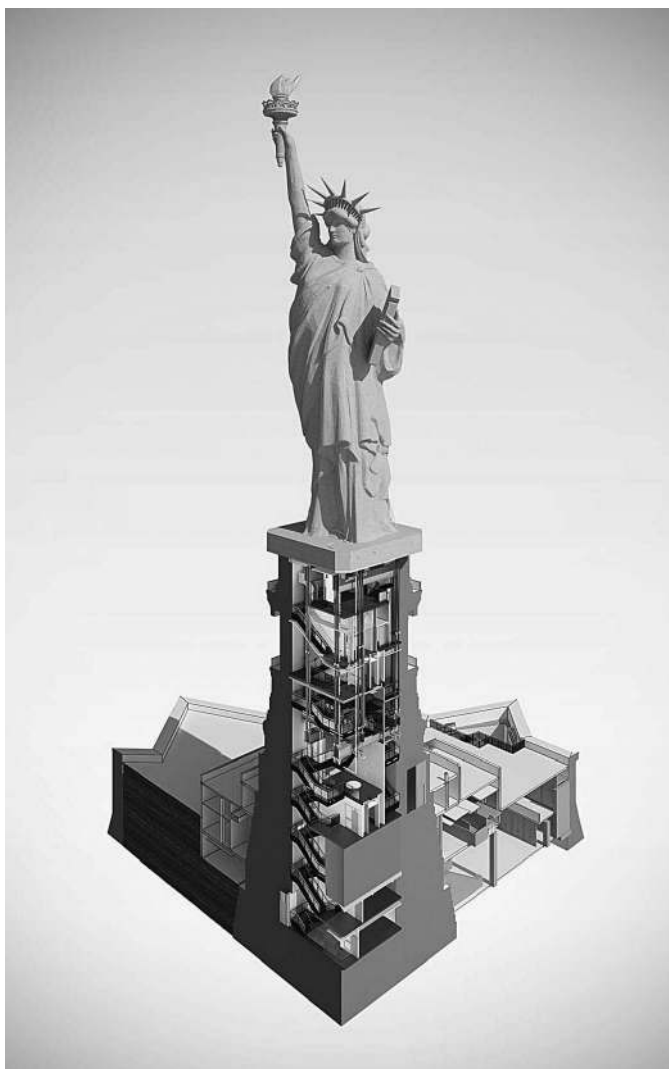
Figure 5. Cutaway view showing the two new stairs in the pedestal. Image by author

elevator design options and then undertook a value analysis of each. The final design solution selected by the National Park Service was to have one stair (Stair A) from the lowest level of Fort Wood to the Observation level of the pedestal to serve as the up stair, and the other (Stair B) serving as the down stair from the observation level to the terreplein. We enclosed the elevator in a two-hour rated concrete shaft, which was a key fire safety code requirement. We kept Stair A as open as possible so that one could have the experience of exploring the statue and seeing and touching the Eiffel beams. Stair B was enclosed in fire-rated panels sheathed in metal, and we designed it as a rated glass tube for part of its length to allow views of historic features. Because Stair B and the elevator have separate two-hour enclosures, Stair A in effect is also rated, as it is within the original concrete shaft of the pedestal.

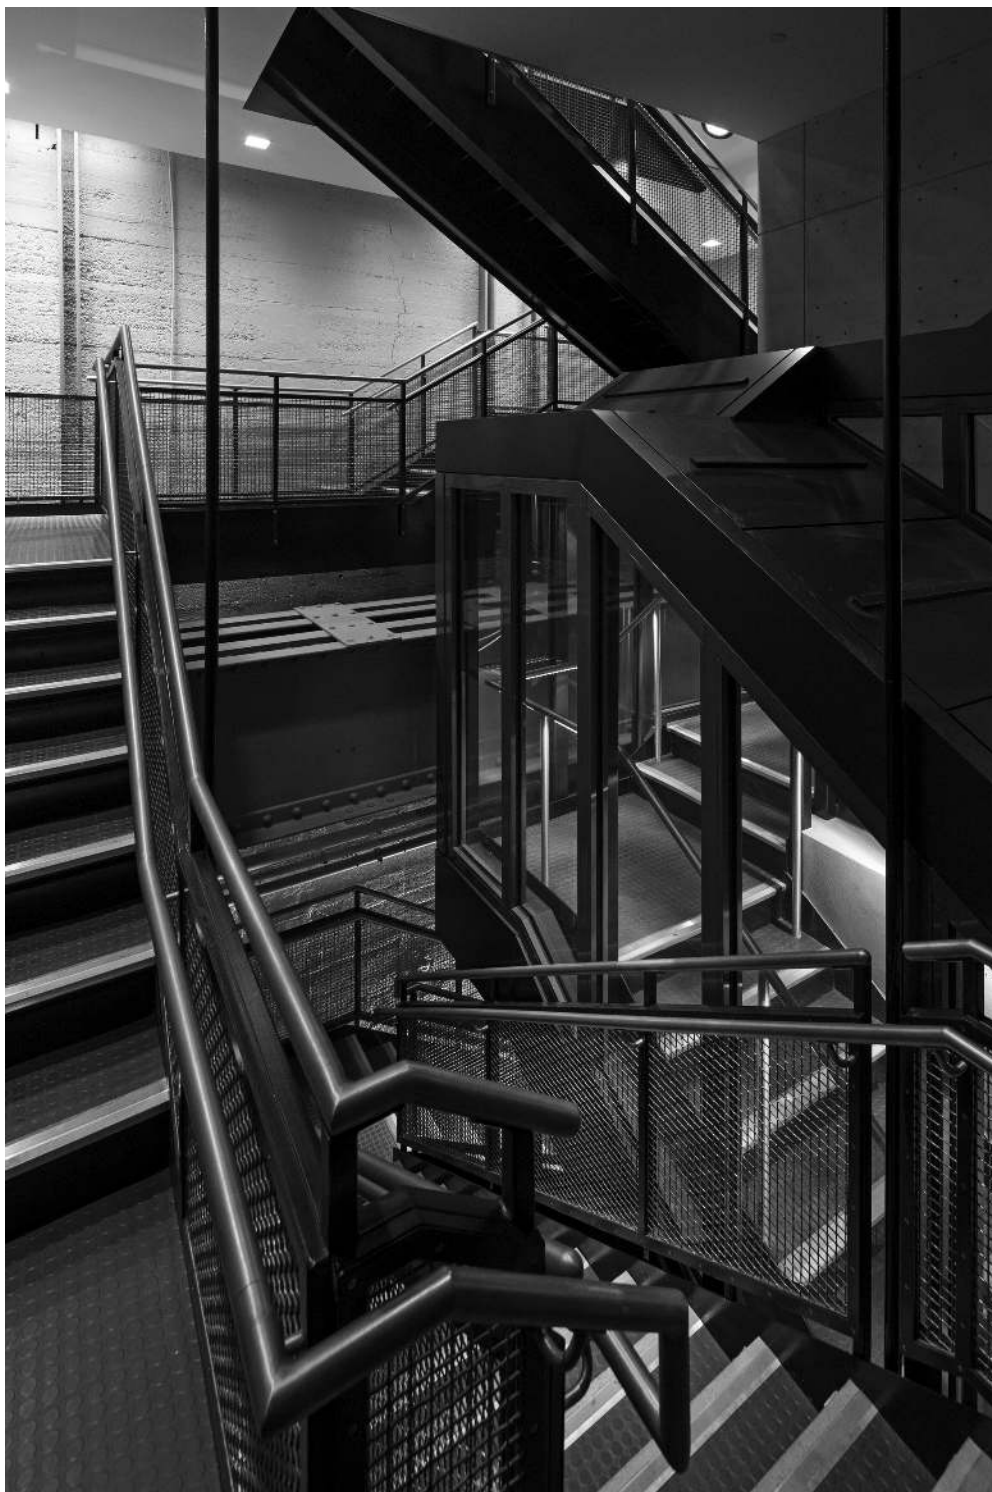
Figure 6. View of the two new stairs moving through the original Eiffel structure. Photo by Brian Rose

The most challenging condition created by the “do not touch” integrity requirement was the lower level of Eiffel beams, at levels 3.5–4.5. Here, both fire stairs were required by the available open spaces in the Eiffel structure to leave their perimeter locations and move through the center opening amid the original structure without touching it. In the current design, visitors are treated to an Escher-like experience of traveling through space in a museum of historic features that includes views into the large girders and bolts that secure the statue to the pedestal. The original interior infrastructure is further enhanced by new lighting that creates destinations along the path toward the observation level.

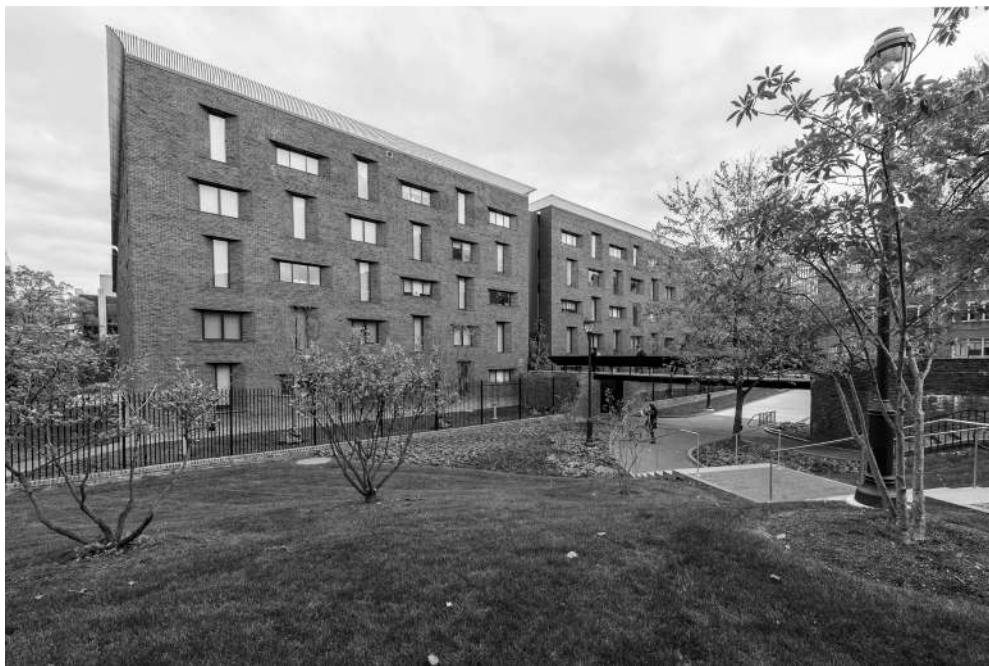
Figure 7. Exterior view of Hill College House after renovation. Photo by Aislinn Weidele

Our objective for the exterior of the building was to make the envelope more energy efficient and sustainable, including a new heavily insulated roof and exterior walls. The robust exterior walls built of rough, handmade Eno brick from New Hampshire were repointed with mortar of appropriate strength, color, and texture. The brick flairs at the

outside corners were either repaired and restored or rebuilt where missing to regain the integrity of the original design. The perimeter steel fence and eyelash cornice were also restored and repainted. More than four hundred existing steel windows were removed, straightened and repaired, double-glazed, repainted, weather-stripped for energy efficiency, and finally reinstalled. Replacement curtain walls in the atrium made use of the existing framing but were double-glazed with laminated glass in gasketed mullions to match the original profiles.

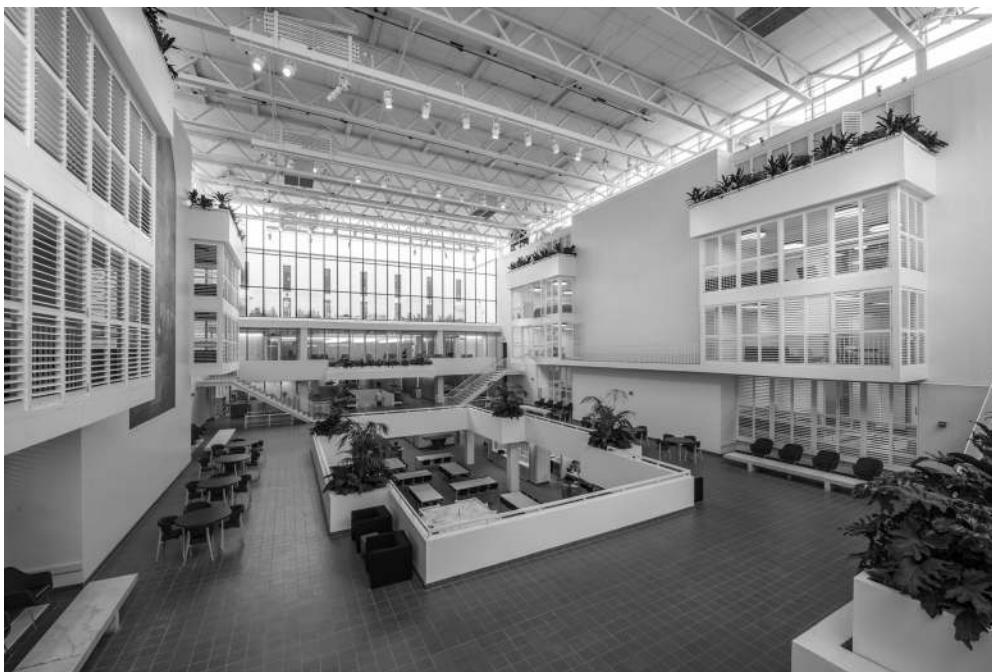
Figure 8. Hill College House atrium after renovation. Photo by Aislinn Weidele

a grand central atrium ringed with dormitory rooms and common lounges. The theme of an urban palazzo is continued in the interior with the atrium, or piazza, containing dining facilities and a central fountain on the lowest level, overlooked by lounges with open balconies and shutters. The atrium is open to all floors, with a range of vertical and horizontal vistas. The space is activated by the students, by the changing quality of light that floods the space from the clerestory level and the upper-level sun decks, and by a marble fountain at the lowest level that was nonfunctional at the start of the project.

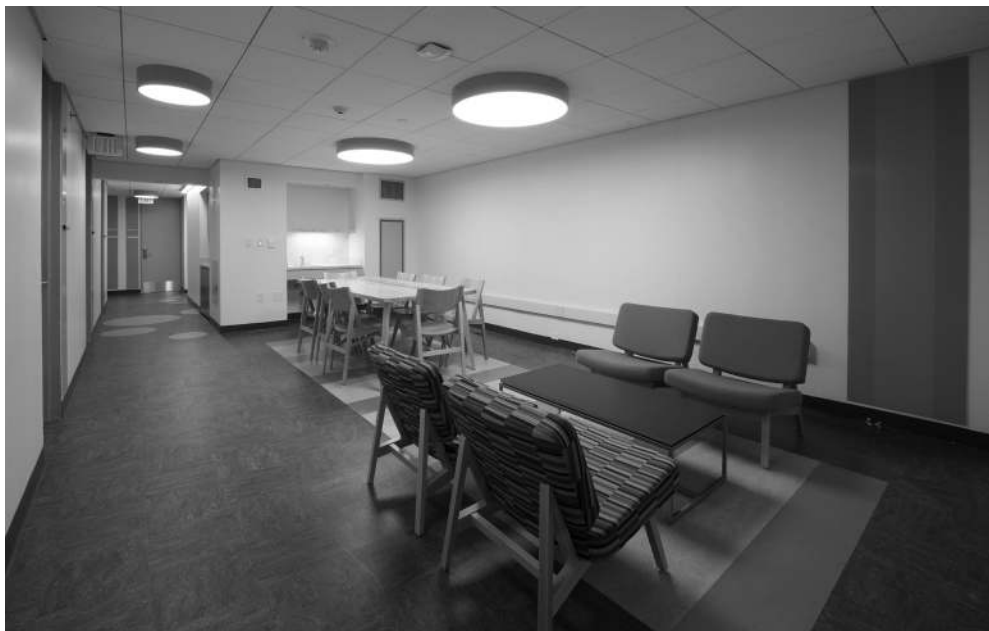
Figure 9. Corridor lounge after renovation. Photo by Aislinn Weidele

In reviewing the original drawings, we learned that Saarinen's intent was to decorate the walls of the lounges with brightly colored stripes, and these were no longer evident. Our conservator conducted paint analysis and confirmed patterns of color that were both intentional and unique to each lounge. Saarinen also designed patterns of floor tile, usually in stripes, unique to each room. We documented an incredible array of colors, and representative samples were restored. While it was impractical to restore original colors in all the lounges, we adapted several designs that became the signature patterns for each house within the residence hall.

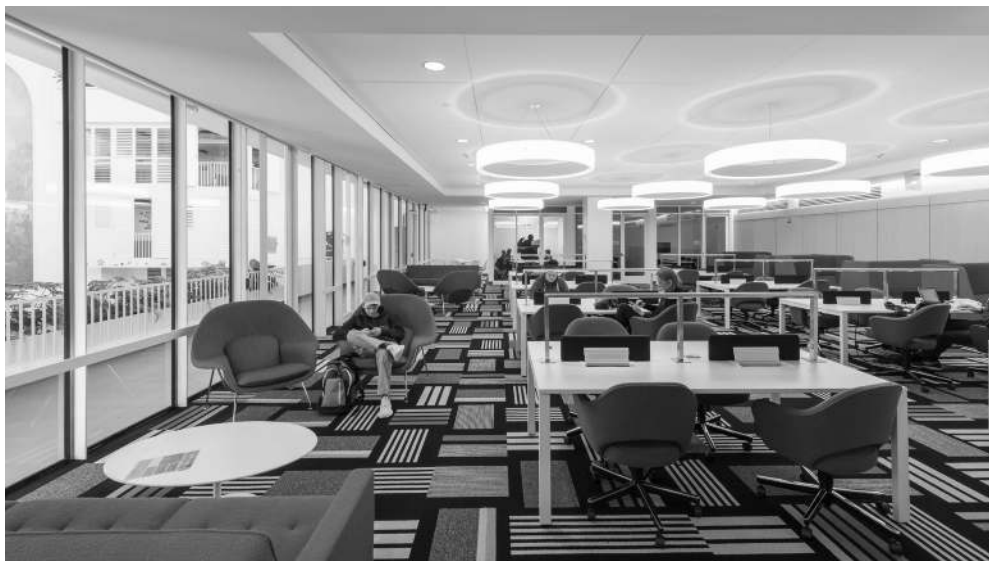
Figure 10. Study lounge interior after renovation. Photo by Aislinn Weidele
